The Vault Under the Porch

Margaret Andrews July 2020

The Burial Vault under the Porch

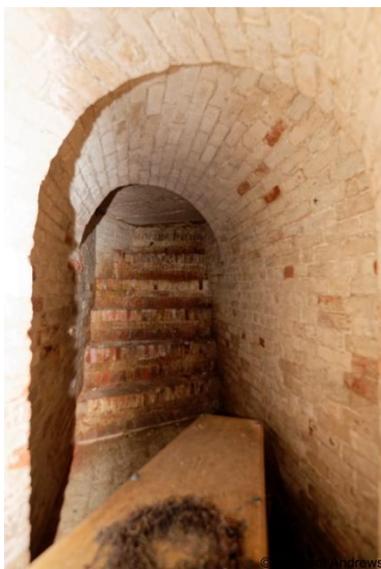
The steps up to the Nave with the corridor blocked by coffin one (Francis Lyon Barrington)

The church access is now closed by what appears to be a stone slab or slabs. It was impossible to get to the steps from within the vault because a coffin had been placed in the corridor. This is coffin one and we will return to it shortly. It is possible to deduce that the entrance in the Nave is to the left (North) of the West door, opposite the font, and in the vicinity of the shelf where the hymn books are stored. At present this area is obstructed by the shelving and carpeting so it is not possible to see where the entrance is exactly.

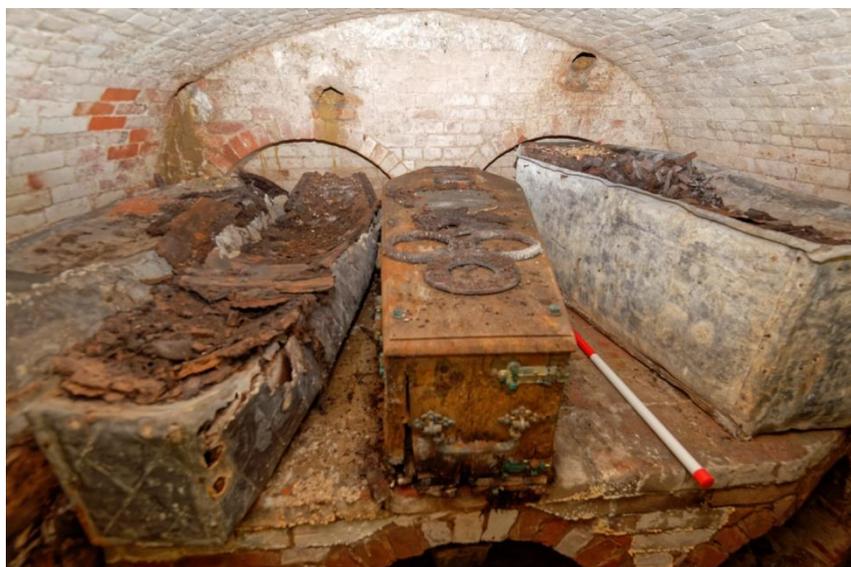
Chamber one – facing the West wall and platform for the coffins (back to the corridor from the Nave steps (coffins 2-5 visible left to right). See the mud streaks from the vent openings on the back (West) wall.

The existence of the vault has almost passed into local folklore, with no-one really sure that it existed. One persistent part of that folklore was that it flooded. This is undoubtedly the case. Mud could be seen streaking down the West wall of chamber one from the vents (see the photo above), and the coffin at the bottom of the Nave steps had water damage along the bottom. The lowermost chamber two coffin (coffin 11) had water lying in puddles on the top suggesting that the water table rises. In chamber two numerous stalactites were held on the ceiling, from water leaching through from above. Overall things were quite wet even after a long dry few months.

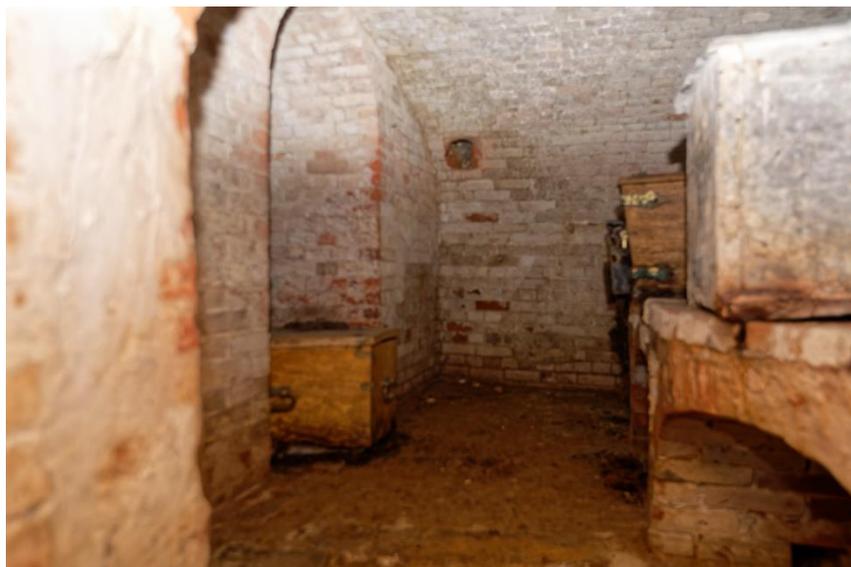
Chamber one from the archway in to chamber two. On left coffin 1 lying in the corridor from the Nave. On the right the platform on its arches with coffin 5 (nearest) and coffin 4 (furthest) visible. Ahead is the vent in the ceiling. This is the one that comes out just to the right of the main porch door.

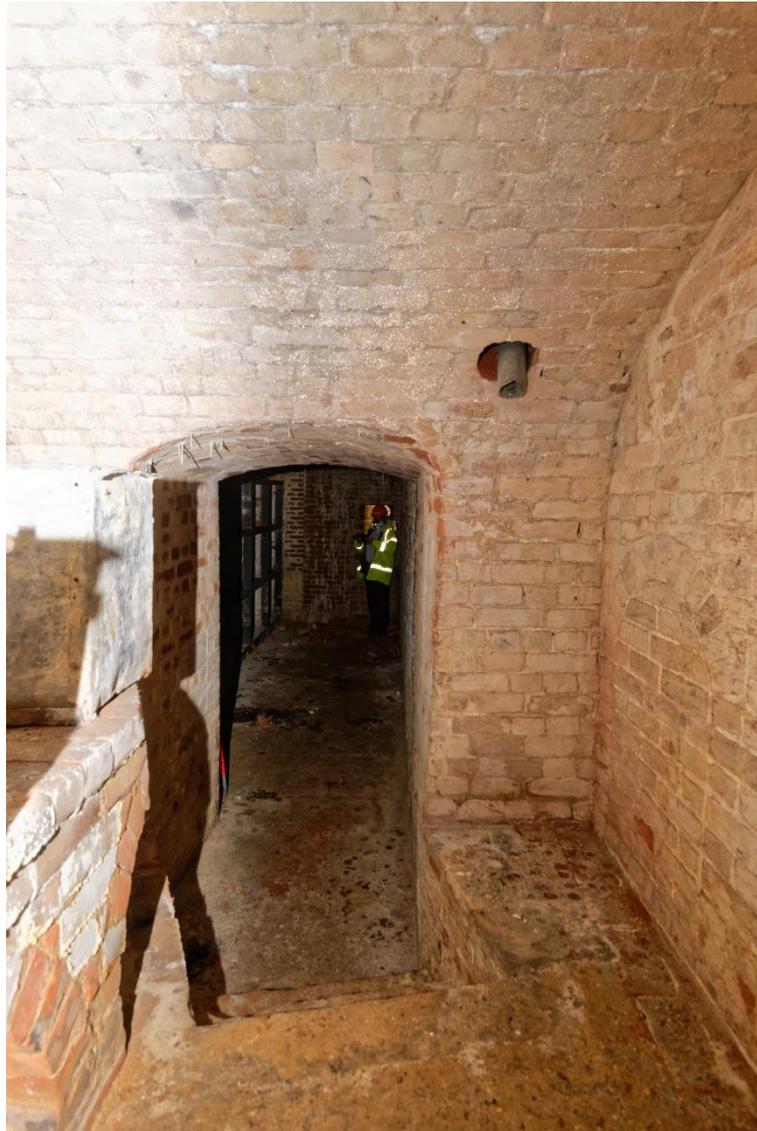
From chamber one looking through the arch to chamber two. Coffin 5 is on the left, ahead in the roof of chamber one is the vent that probably appears in the wall to the left of the closed off door on the North side of the porch. The steps lead down from chamber one through the arch into chamber two where faintly on the left can vbe seen the bank of coffin niches with their black surrounds.

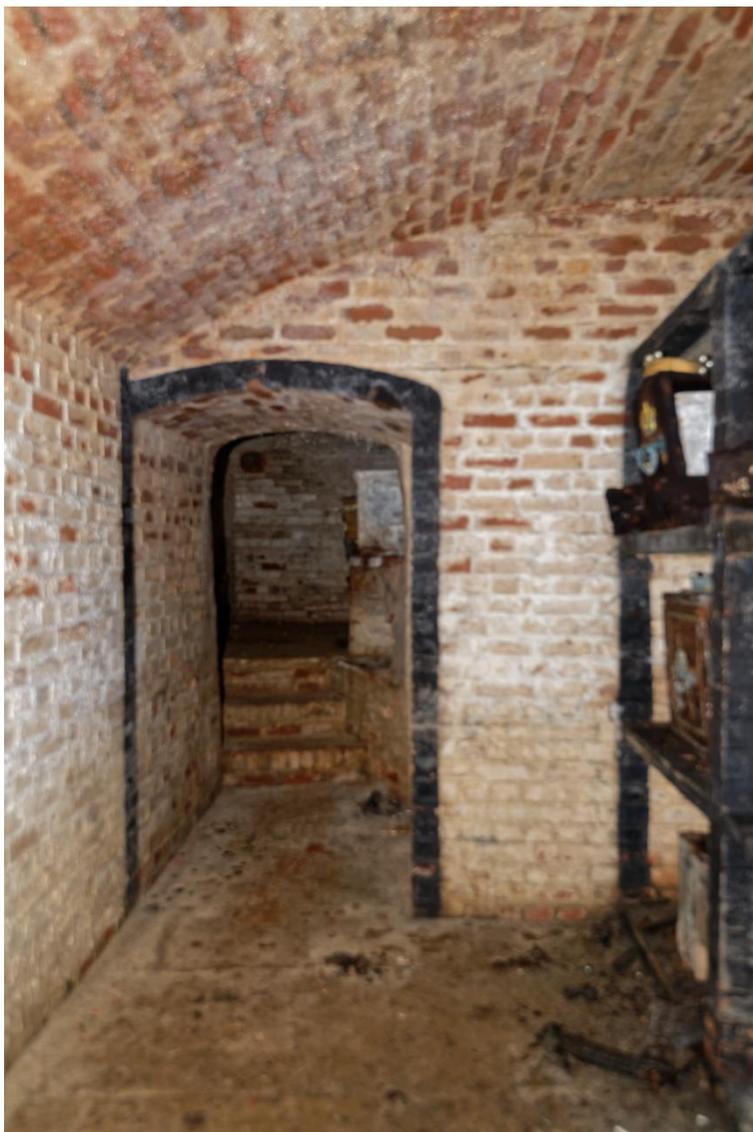
From within chamber two looking back to chamber one. Notice the black door surround and the black edges for the coffin niches (on the right) The coffins in the niches that can be seen in chamber two are 9 at the top, 10 middle and 11 bottom.

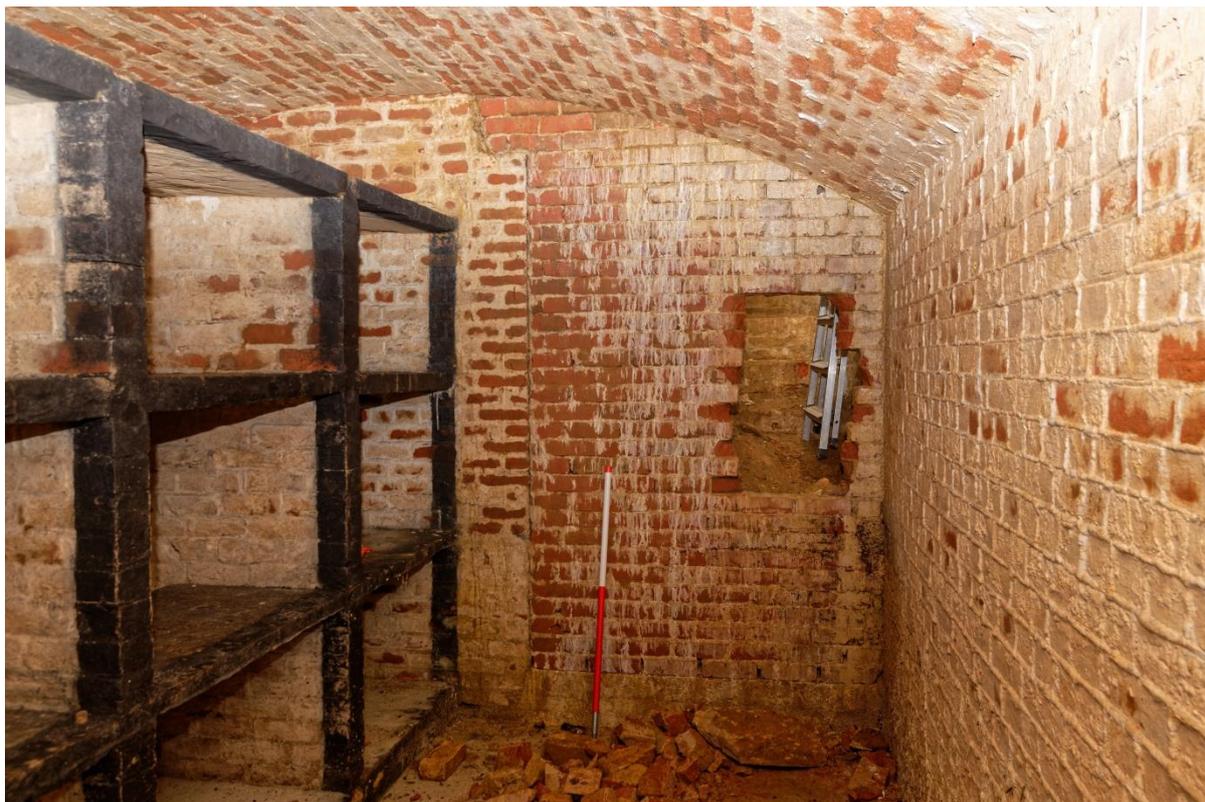
Chamber two looking North. The bank of niches on the left this time with the breach in the North wall and the churchyard steps with the modern stepladder beyond.

This second chamber was also brick built and organised with three rows of shelving along the West wall, divided into six columns, giving 18 potential individual coffin places. Only four of these had been used (coffins 9-12).

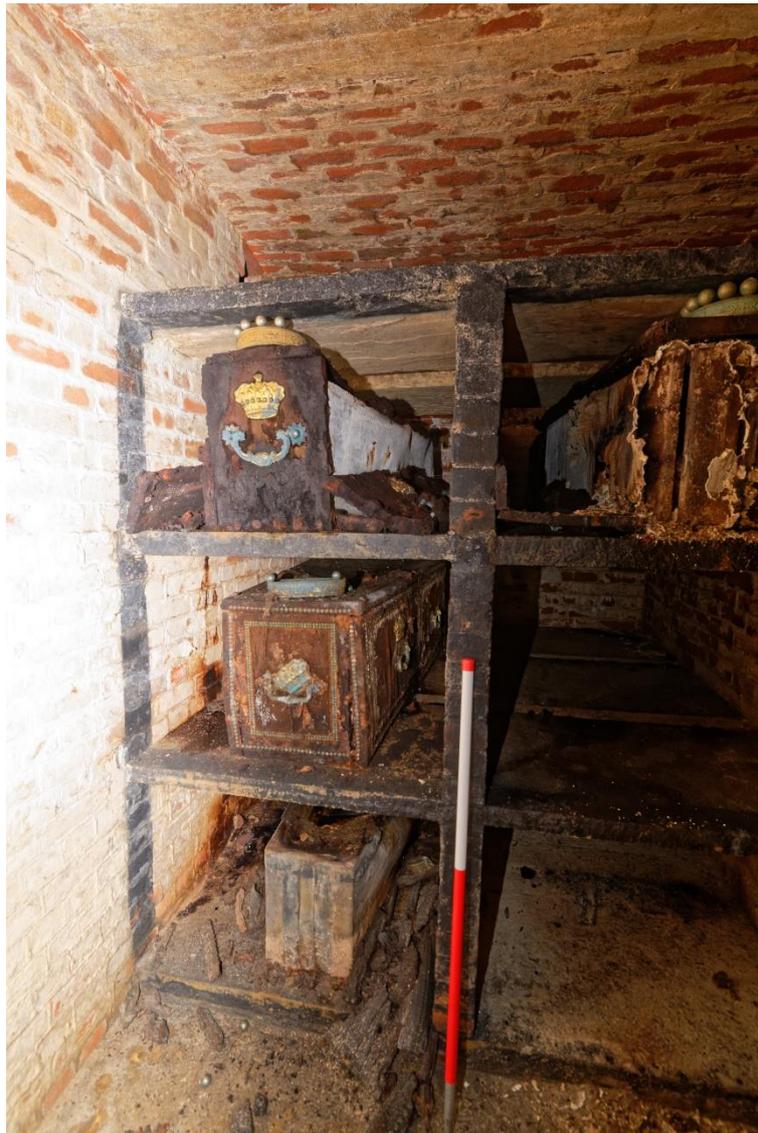
East Facing Sketch Section Through the Mouths of Bank of Coffin Niches, Chamber Two

Chamber two – in the left column coffin 9 at the top, 10 in the middle and 11 at the bottom. Coffin 12 in the top niche of the next column. Note the coronets on three of the coffins

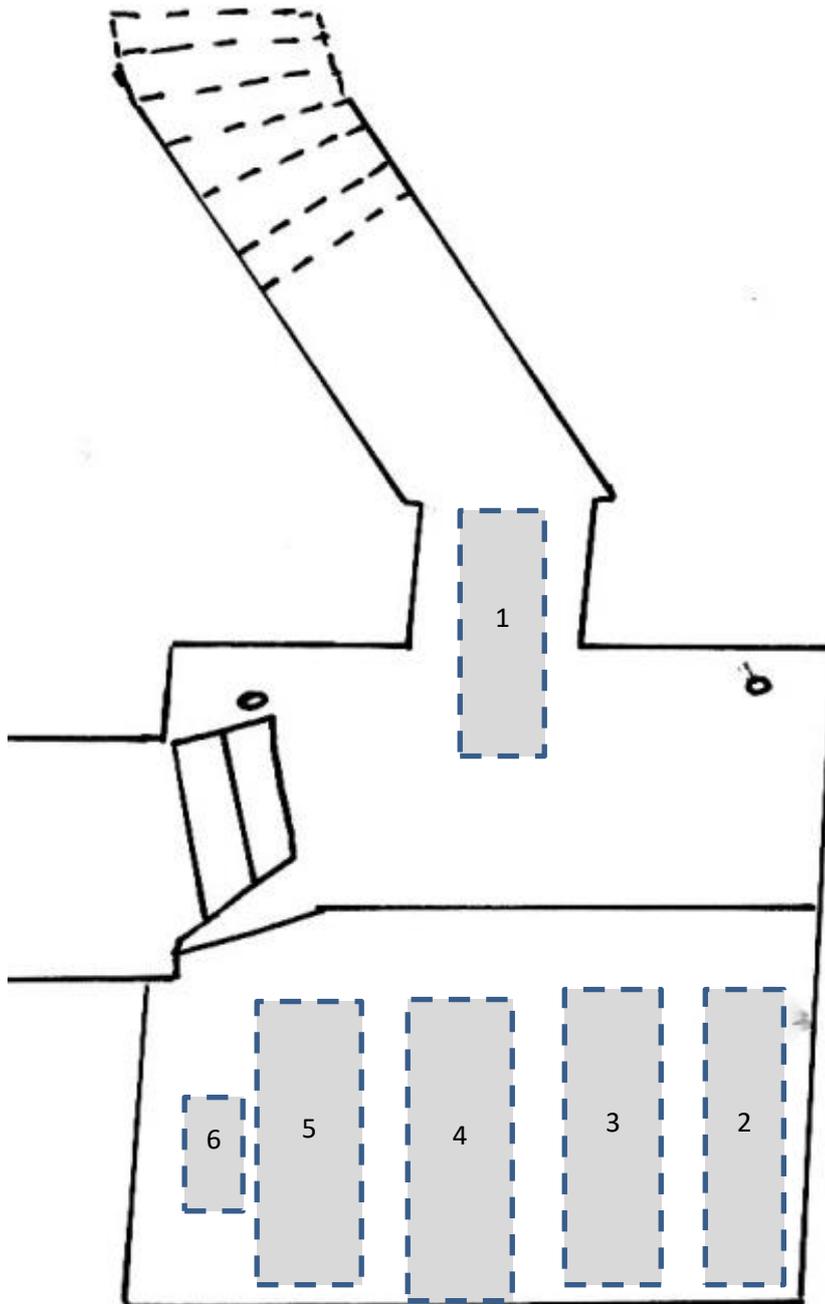
Plan of Chamber One to Show Location of Coffins 1-6

(Coffin 7 lies under coffin 2, and coffin 8 lies in the arch under coffin 4)

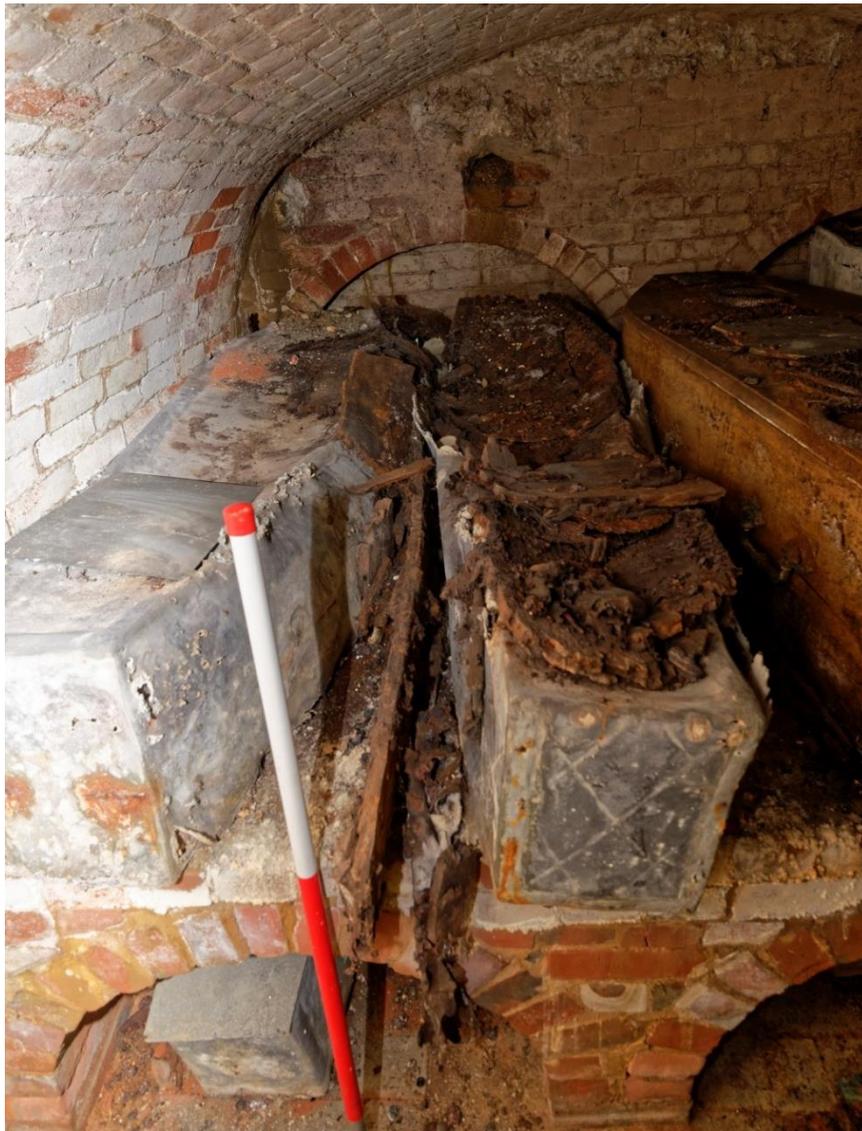
Chamber one with coffin 2 (Admiral Samuel Barrington) on the platform on the left and coffin 3 (unknown) beside him. Coffin 3 has incised diamond patterning in the lead and you can see wood has fallen away from these two coffins. Underneath, under the arch is coffin 7 (unknown). The plaque giving the name is on top but unreadable. Interestingly it has been clearly moved and this coffin in clear of wood debris. Although the plaque clearly has the screw holes to attach the it. This suggests that there has been a bit of tidying up at some point down here.

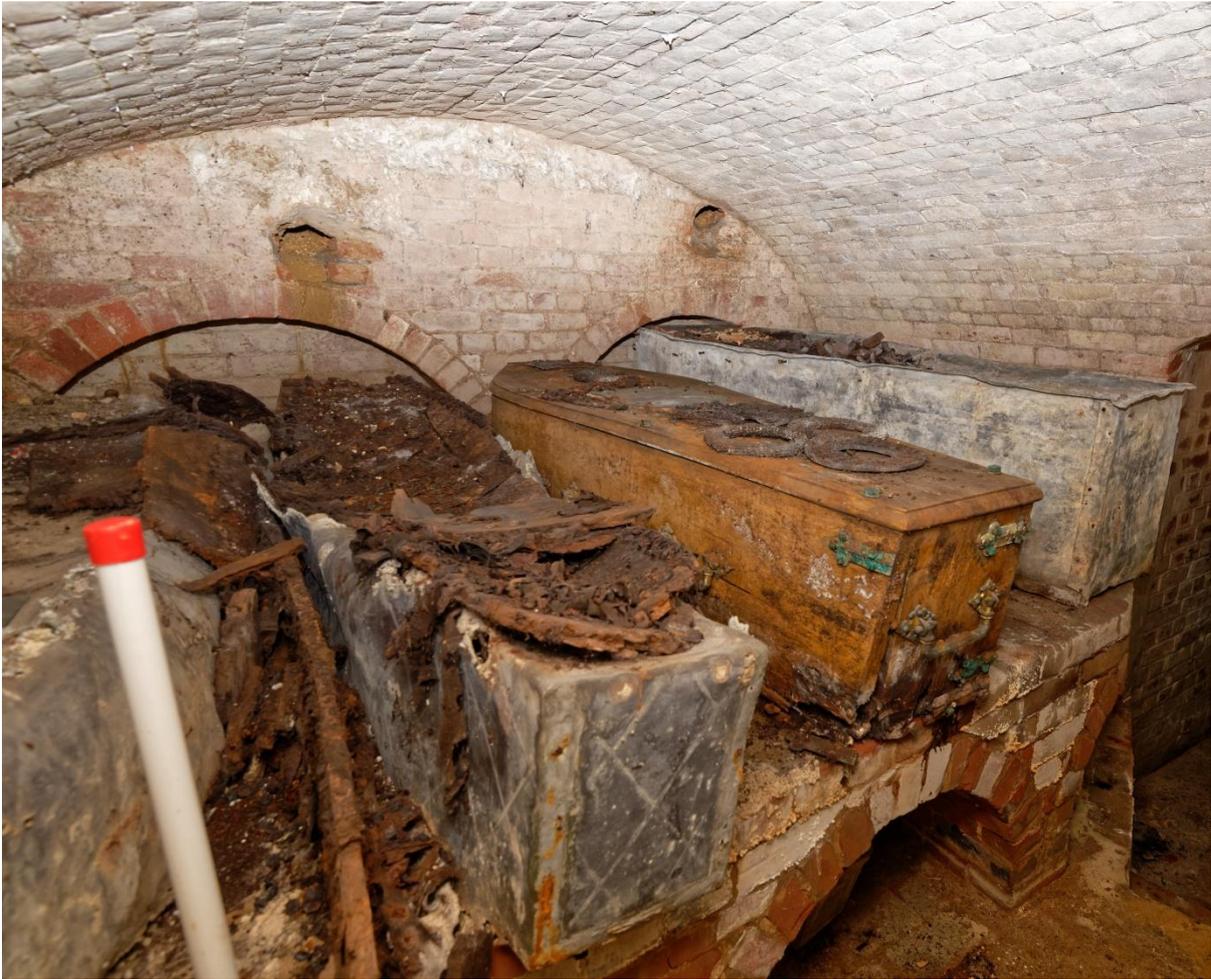
Chamber one platform with coffin 2 (Admiral Samuel) on the extreme left, then coffin 3 (unknown) coffin 4 (Maria Jane Barrington) and finally coffin 5 (unknown). The archway visible is the middle one where coffin 8 is lodged.

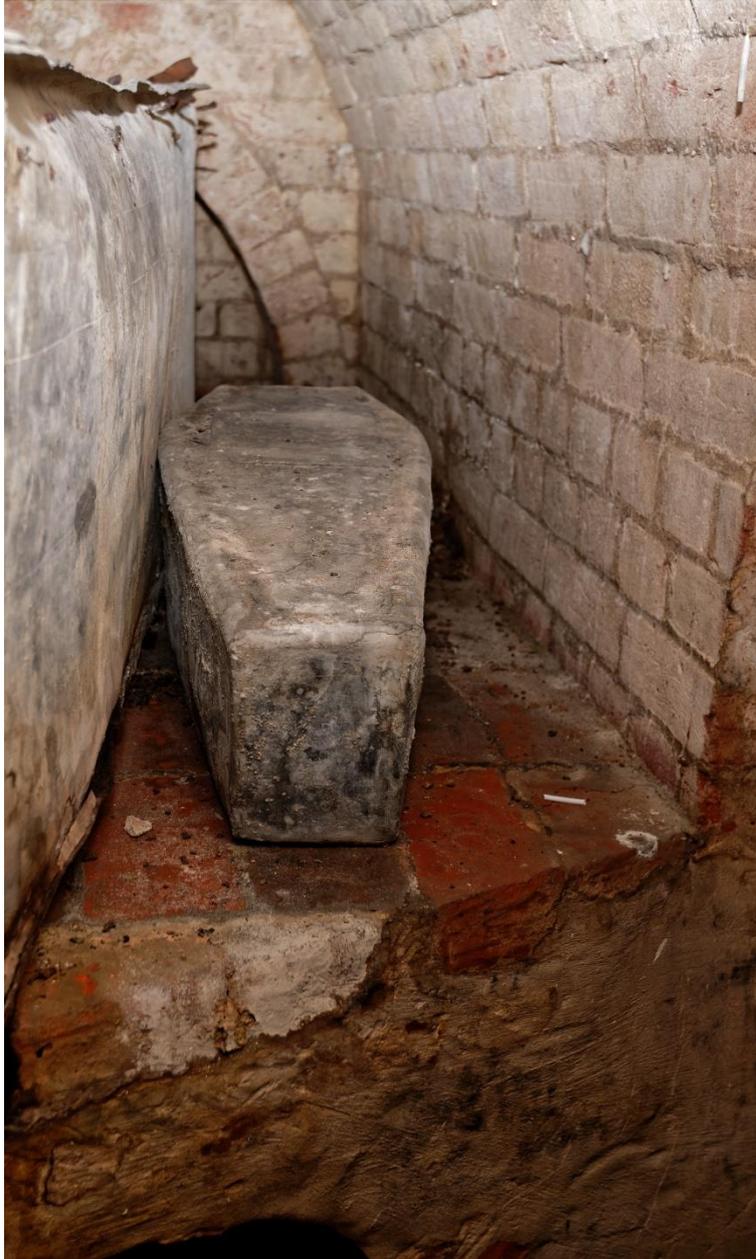
Coffin 6 on the extreme right of the platform in chamber one. This is marked Hon. William Hill Barrington age 4 hours. He was the son of the 2nd Viscount William Wildman Barrington

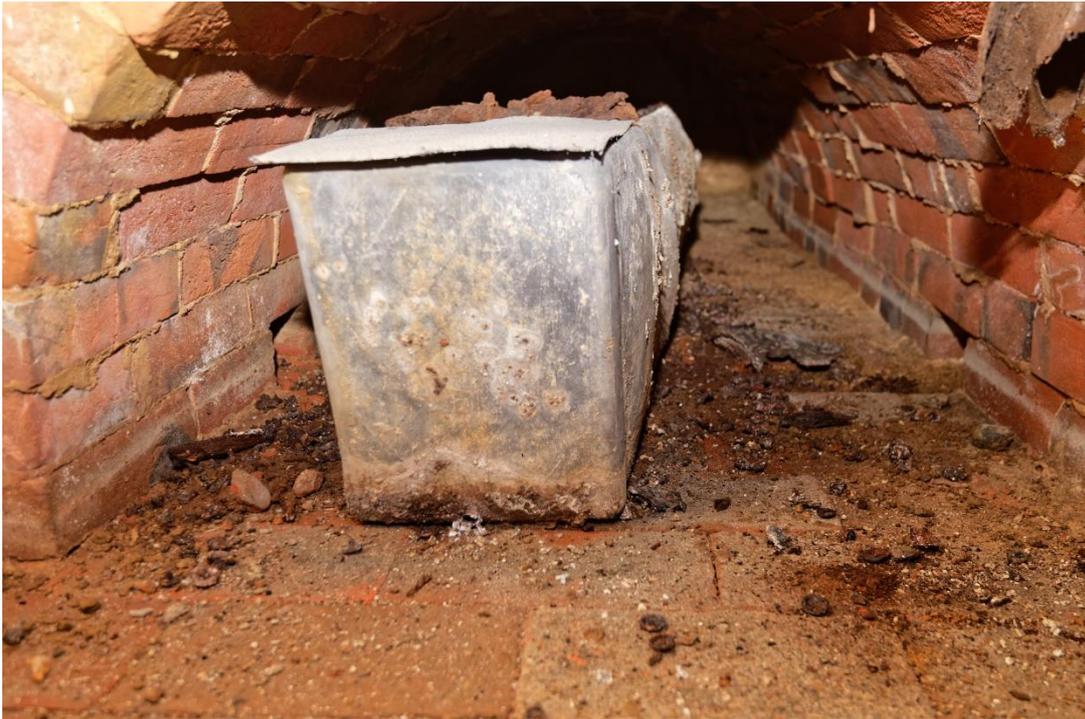
Coffin 7 (unknown) You can just see the diamond decoration of the lead similar to coffin 3. Notice how tidy this coffins surrounds are, and the following one.

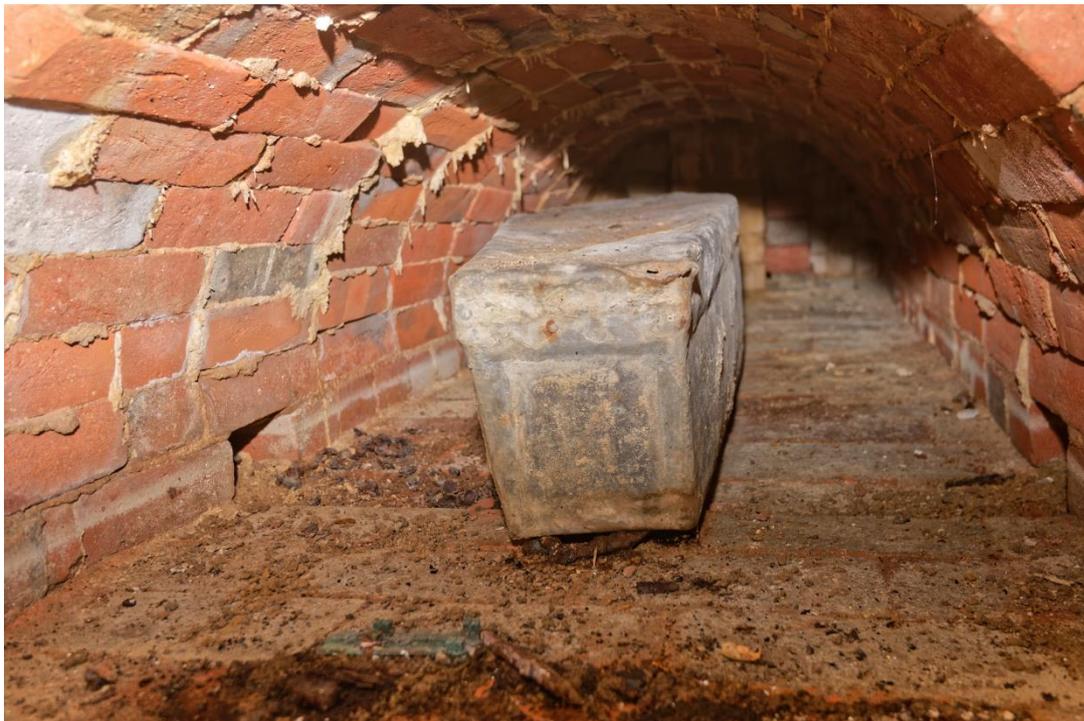
Coffin 8 (unknown but maybe Rothesia Ann).

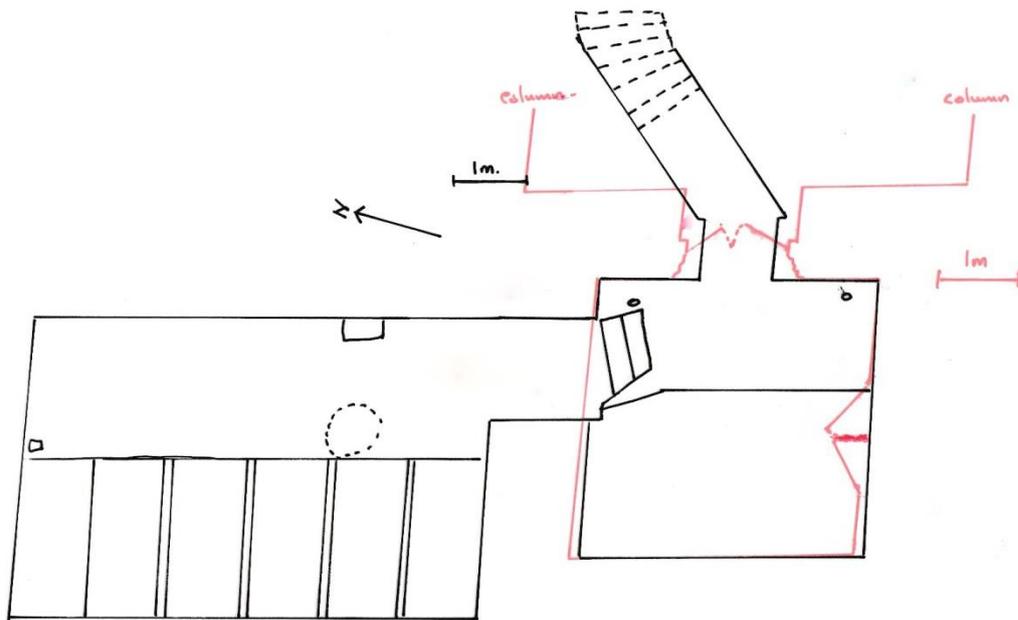
It seems most likely that chamber one was built at the same time as the porch which is generally said to be early 18th century. This is practically confirmed by superimposing the plan of the vault with that of the porch and West entrance at ground level (see below). The fit was remarkable and shows that the archway from the chamber to the Nave steps corridor lies directly under the West door. It is from this that it is possible to deduce the position of the entrance to the vault.

Plan showing the vault (in black) with the ground level plan of the interior walls of the porch and West entrance to the Nave.
