## The Medieval Church Fabric – A Tour

(Margaret Andrews March 2020)

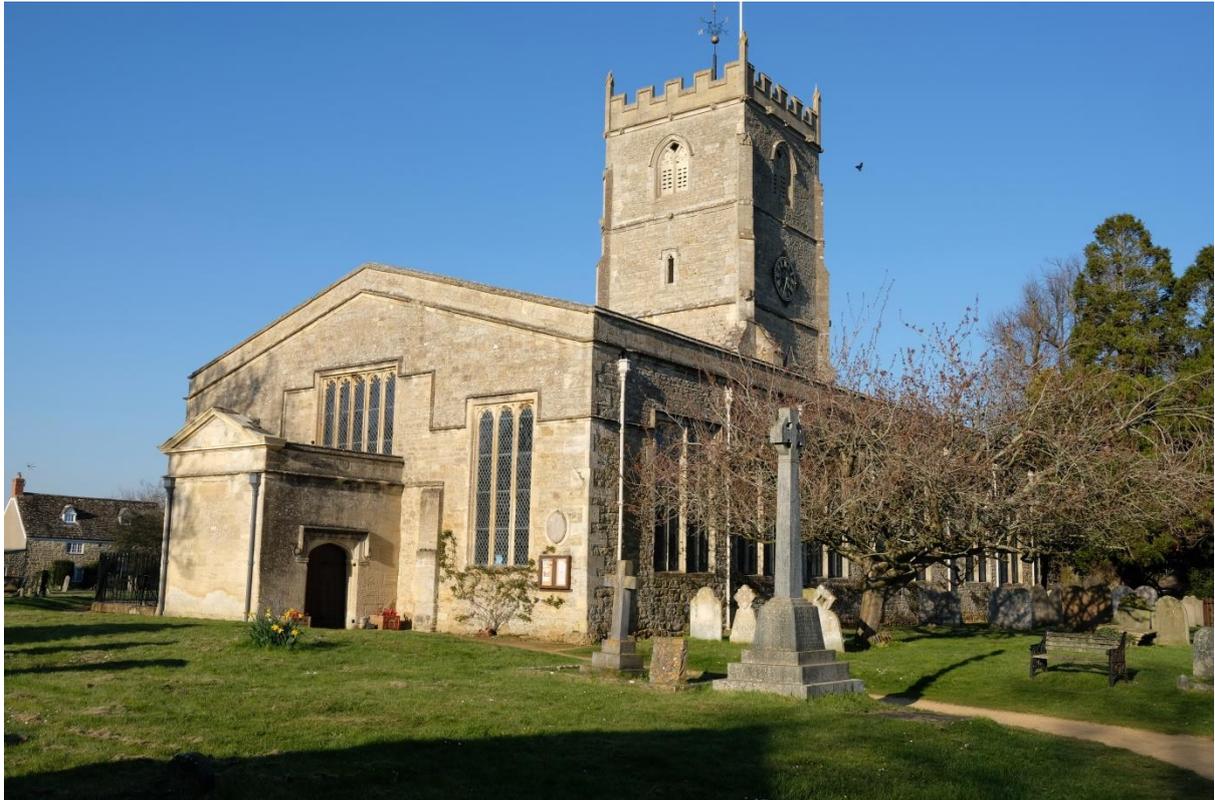
St Andrew's Church Shrivenham is widely regarded as a fine example of a seventeenth century church. However some of the medieval fabric remains visible if you look closely.

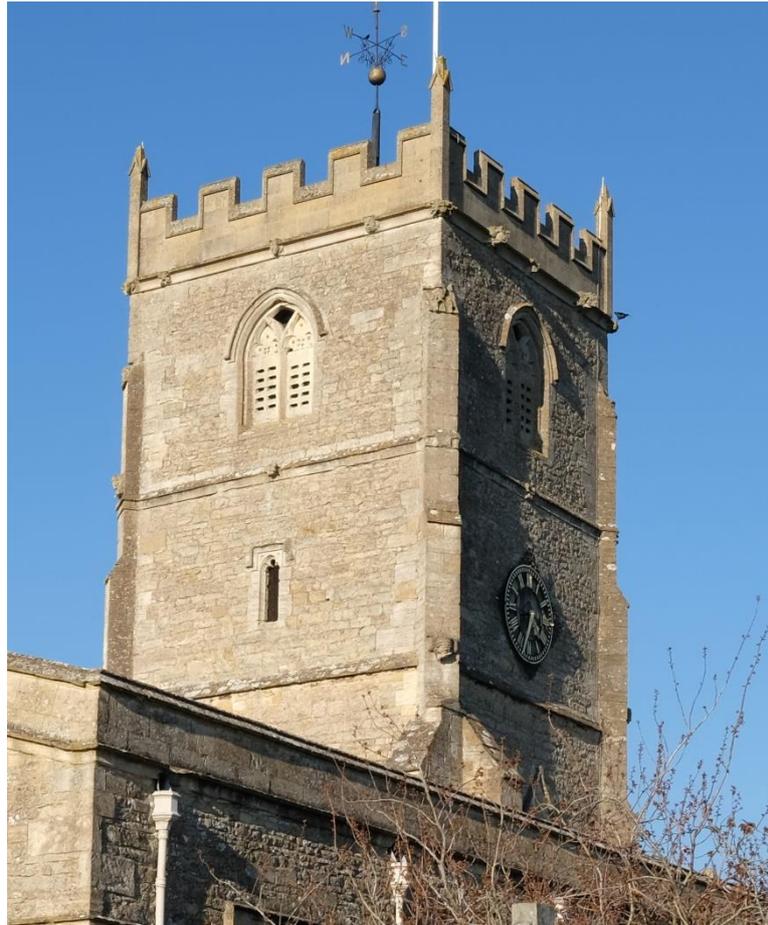
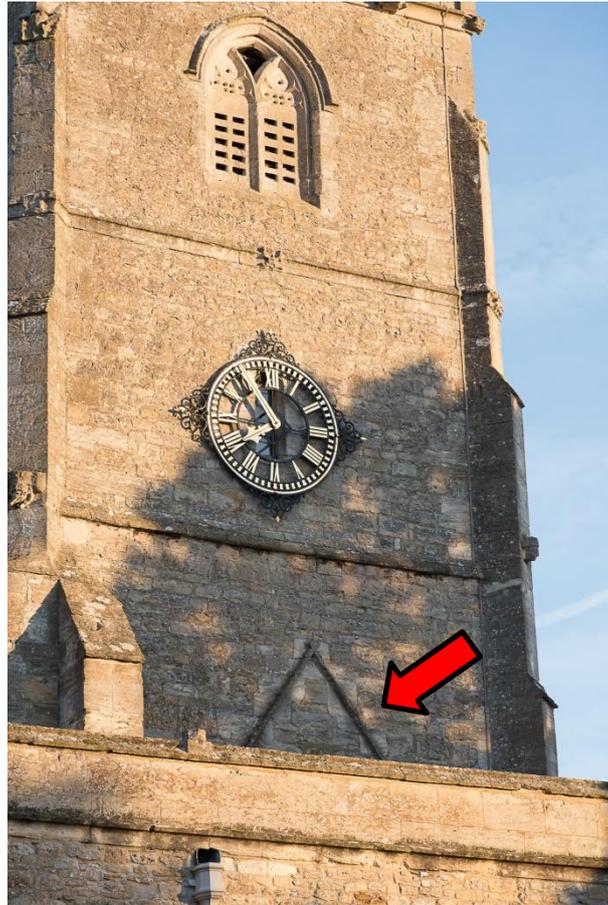
This is thought to date to the 15<sup>th</sup> century. Interestingly interior aspects (see below) suggest that this may be early rather than late 15<sup>th</sup> C as is sometimes suggested.

If you look at the West/North and South faces of the tower you can see the lines of the old roof showing that the pitch was much greater than it is now, and also suggesting that there were North and South transepts, making this a cruciform shaped church during the medieval period rather than the rectangular structure that we see today.

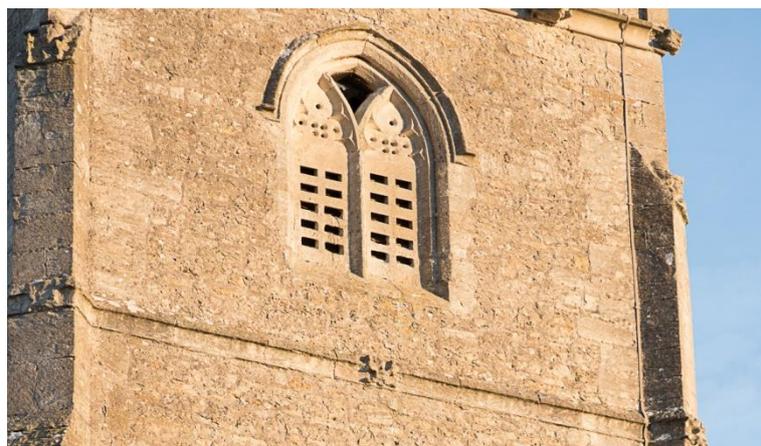
Looking further up the tower we see windows with typical gothic pointed arches.

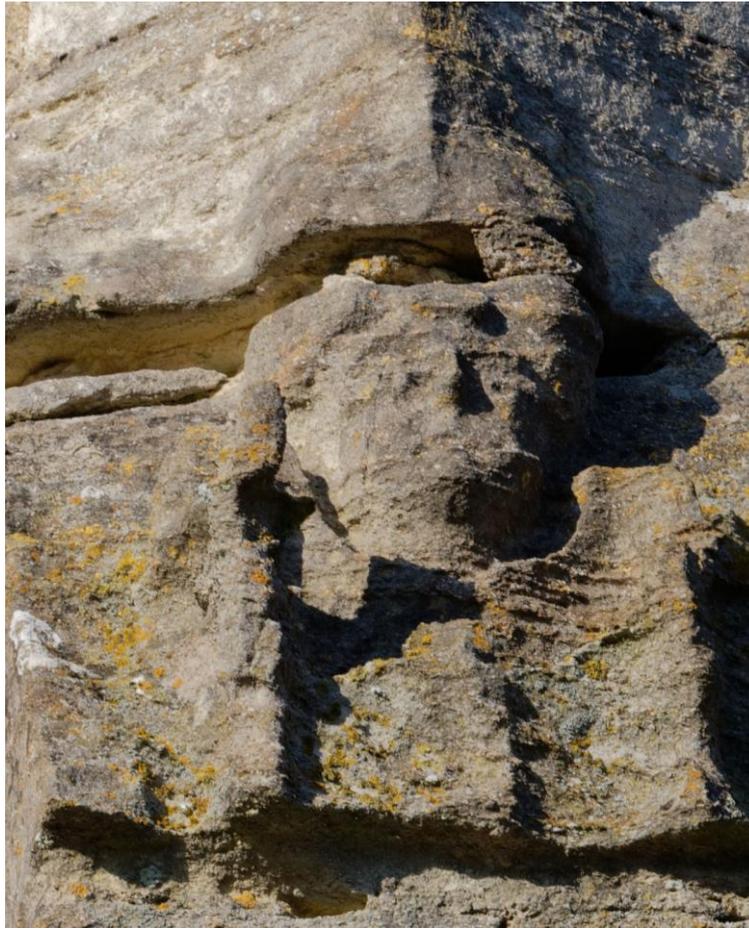
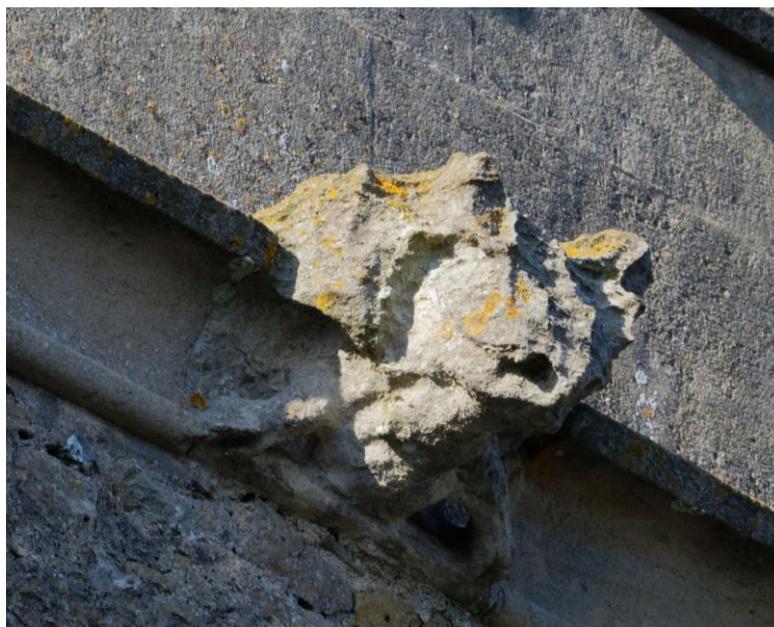
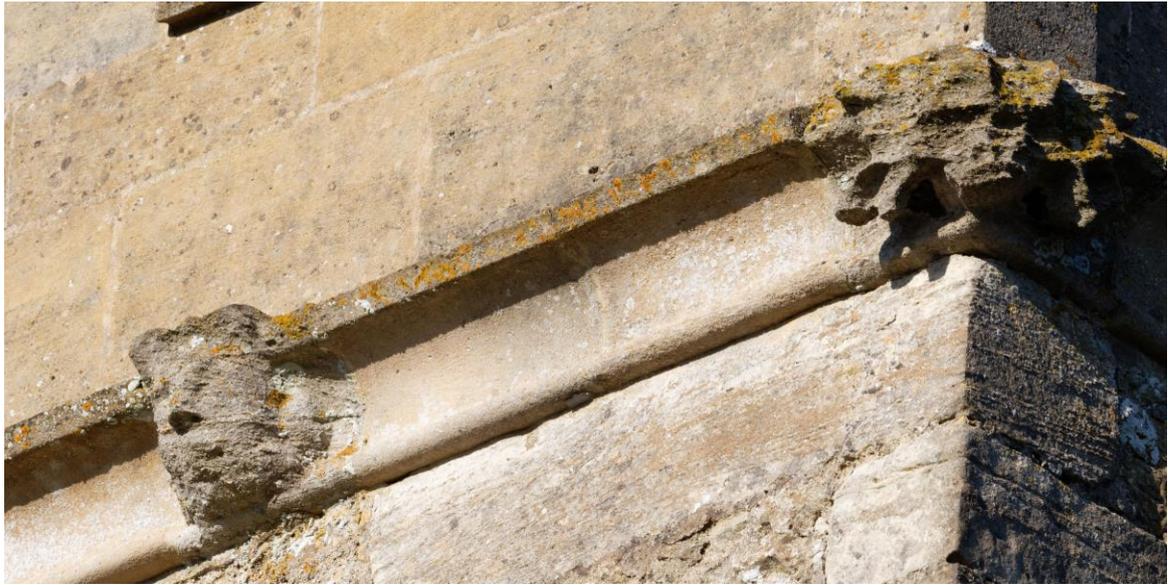
And finally both at the top and on the buttresses are several gargoyles and grotesques. Sadly these are in poor condition.

The gargoyles have the water spout for drainage, while the grotesques are the other carvings

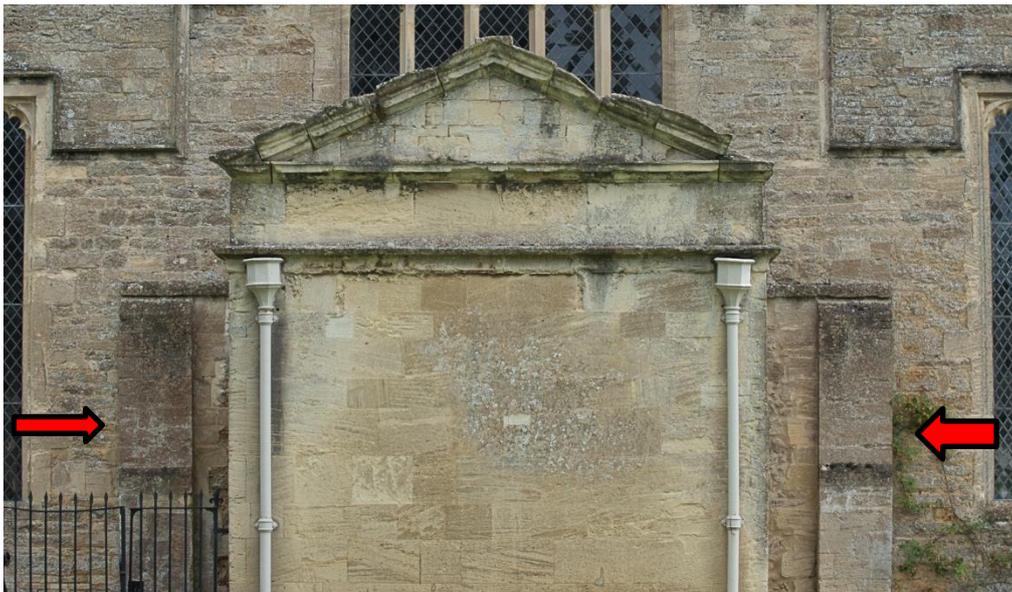
Next we approach the West end of the Church. The large seventeenth century porch dominates this view but if you look at the West end wall you will see two external buttresses.

These features although they were used in many periods tend to be characteristic of the later Norman or early gothic periods (later 12<sup>th</sup> to 13<sup>th</sup> Centuries). Their function was to help take the load of the internal arcade of arches. Interestingly the ones here are on the same line as the existing pillars suggesting that the pillars are likely to be in the same alignment as these of the medieval church

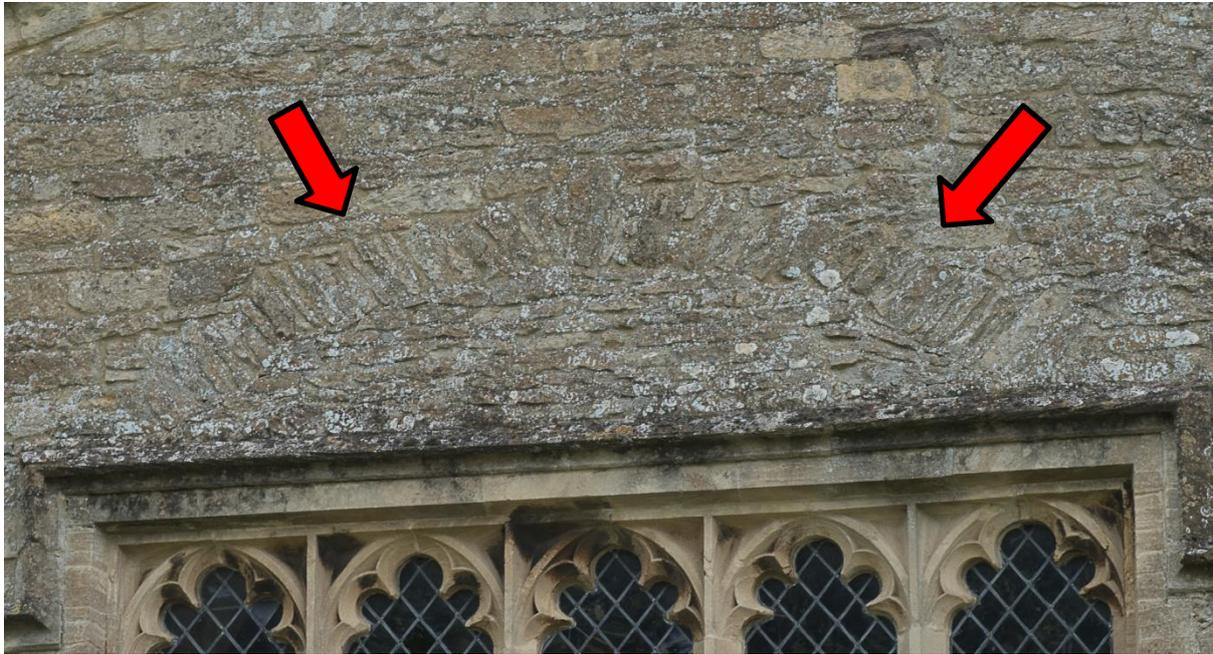
Look at the relieving (or discharging) arch above this window. Again this could appear at any date but was particularly characteristic of medieval windows and doors. Its function was to do exactly as described, to spread the load of an opening. Interestingly despite the superficial similarity of all the church windows this is the only one with a relieving arch.

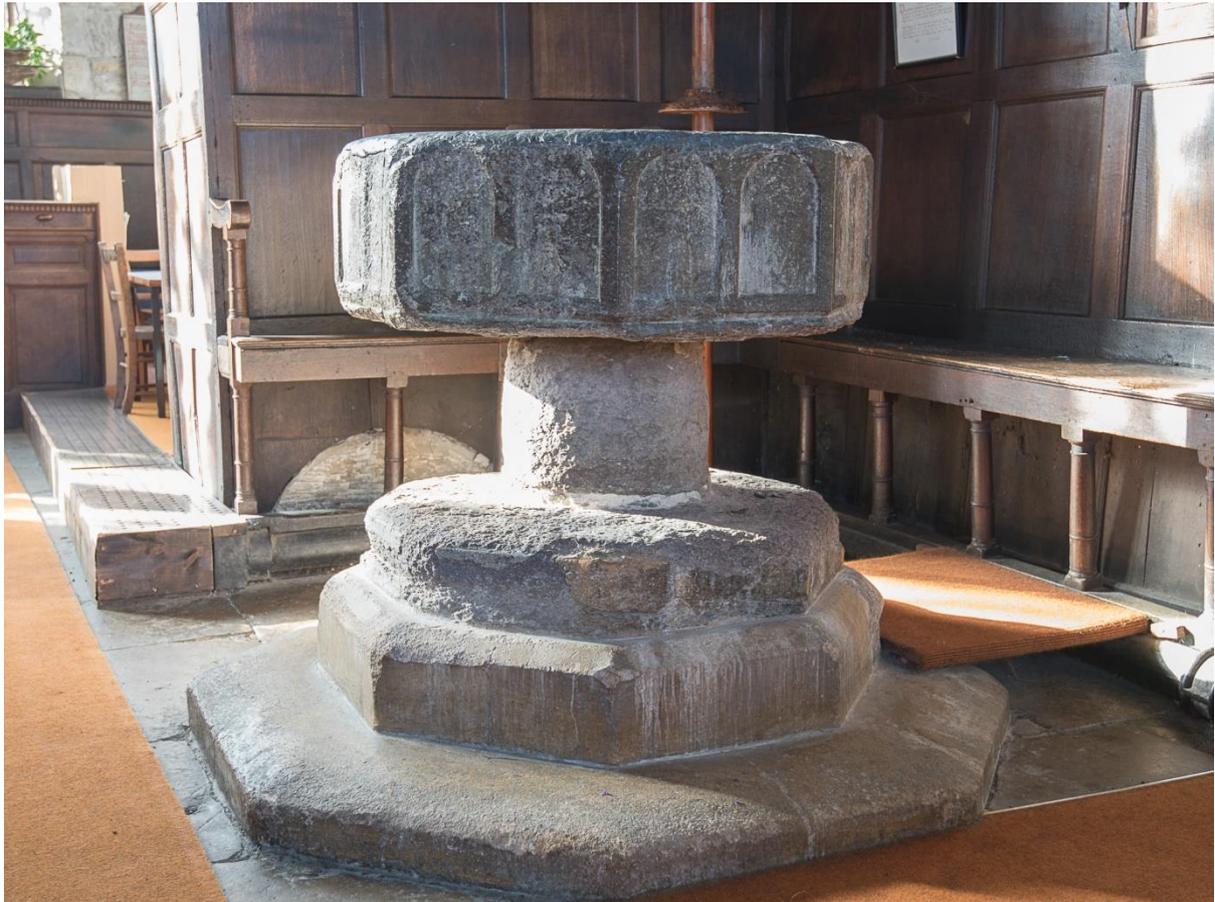
Immediately inside the door on your right is the font. This is of Purbeck Marble and is considered to date to either the late twelfth or the thirteenth century. The font is octagonal and has blind arcading around the outside. The blind arcading is consistent with this dating.

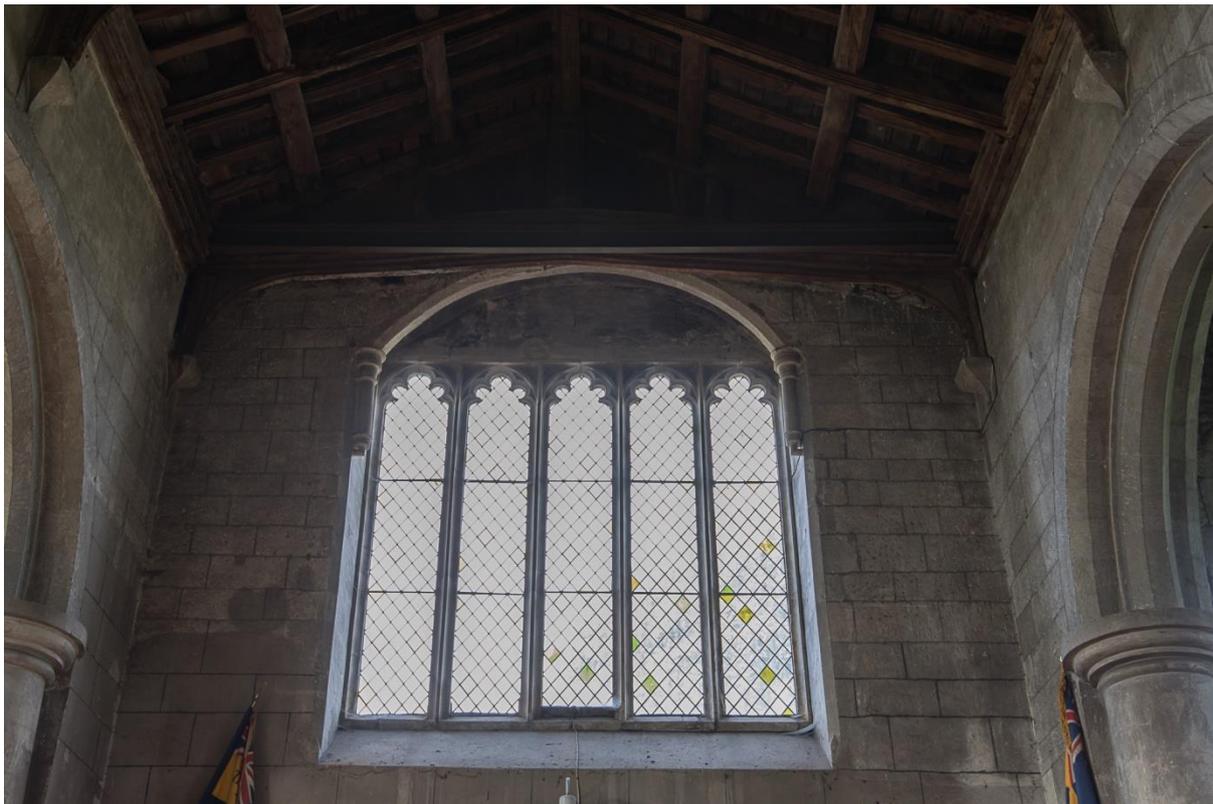
If you look it is apparent that this window is different from the other windows in the church.

The beam of the roof comes lower than the window arch suggesting that the roof is of later date than the arch. We have already seen that the earlier roof had a much higher pitch, so this window opening is likely to predate the lowering of the roof whenever that occurred.

Next if you look at the arch itself it does not look quite right. The arch is slightly distorted and the way that it springs off the corbels provided by the two small columns looks at best uncomfortable. It may be that there has been some adaptation here.

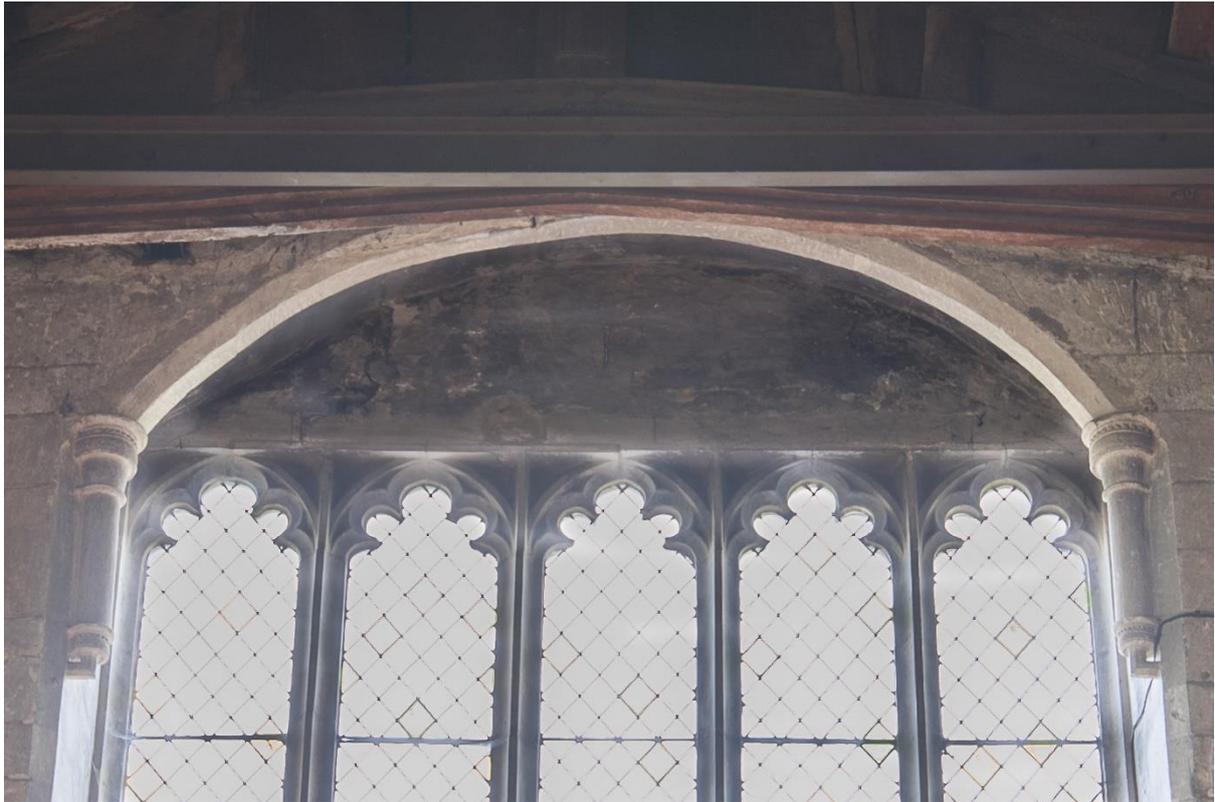
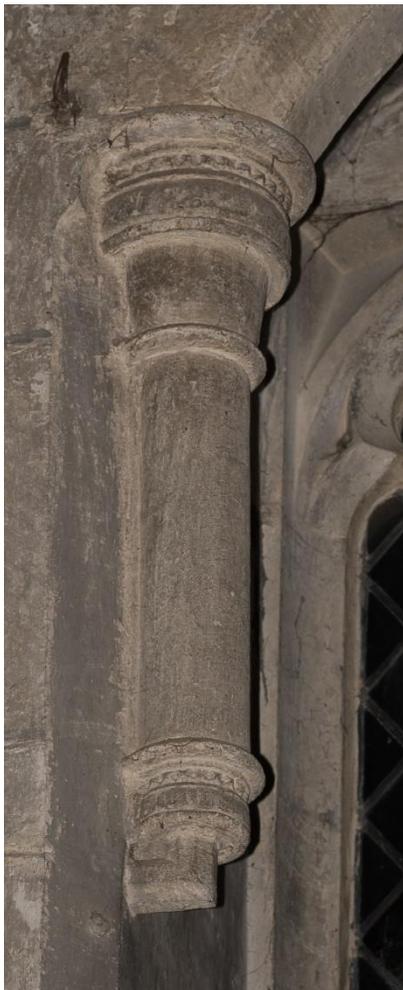
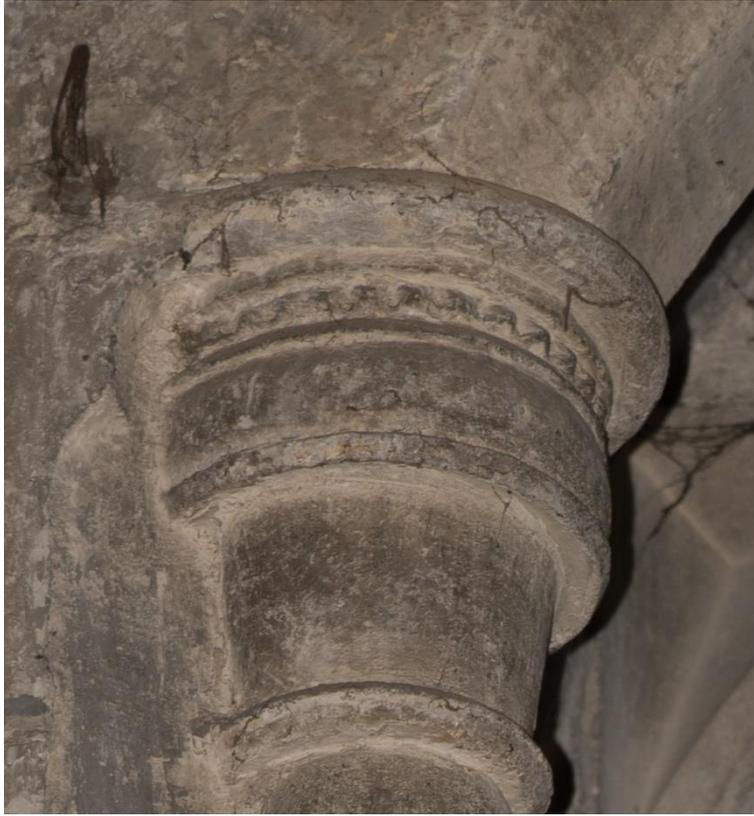
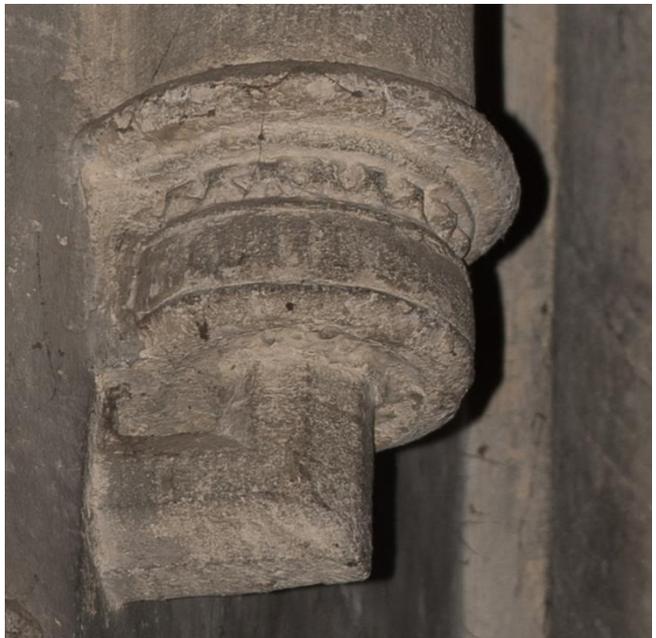
The small pillars of the window frame are themselves of interest.

Look particularly at the top and bottom and the decoration there.

This early gothic dogtooth decoration probably dates to the 12<sup>th</sup> or early 13<sup>th</sup> century.

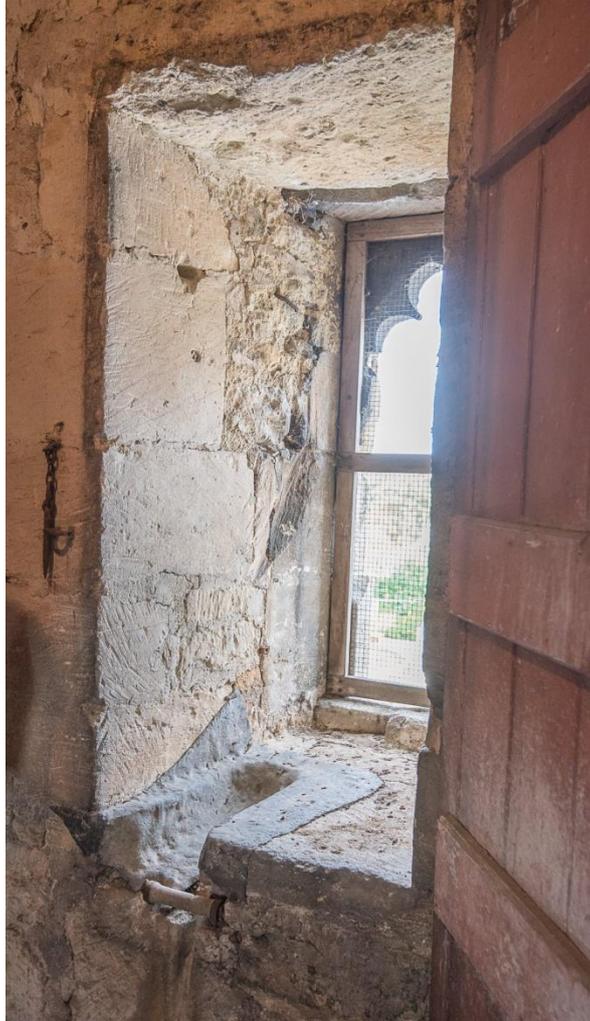
Here a deep groove is worn in the sill of the East of the window. The sanctus bell once stood in this window and its rope pulled over the sill.

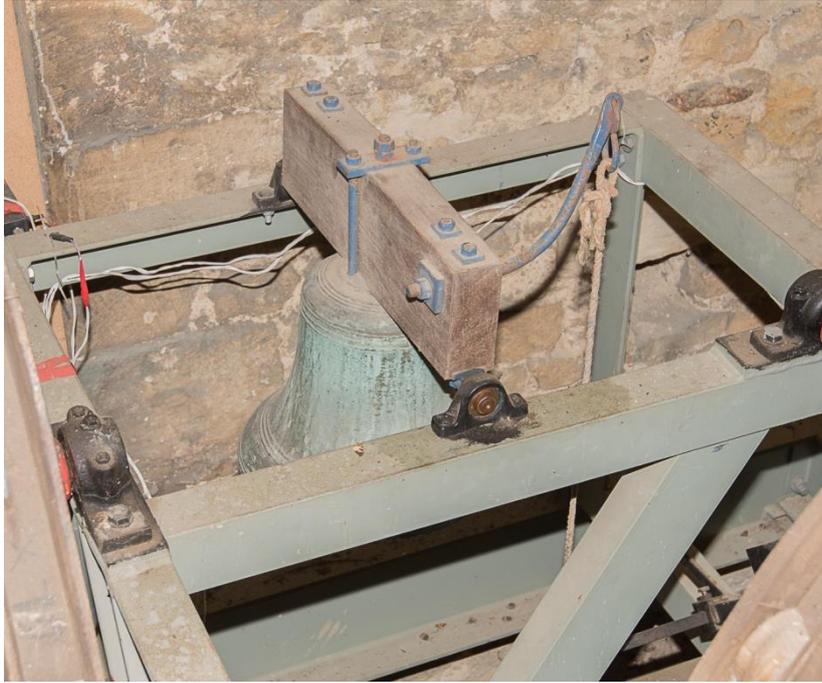
This bell is now higher in the tower lodging with the big bells that are rung for services. The sanctus bell still performs its old task of calling the faithful to worship just before the service starts.
