SOUTH WILTSHIRE
INDUSTRIAL ARCHAEOLOGY SOCIETY

FLOATED WATER MEADOWS IN THE SALISBURY AREA

MICHAEL COWAN

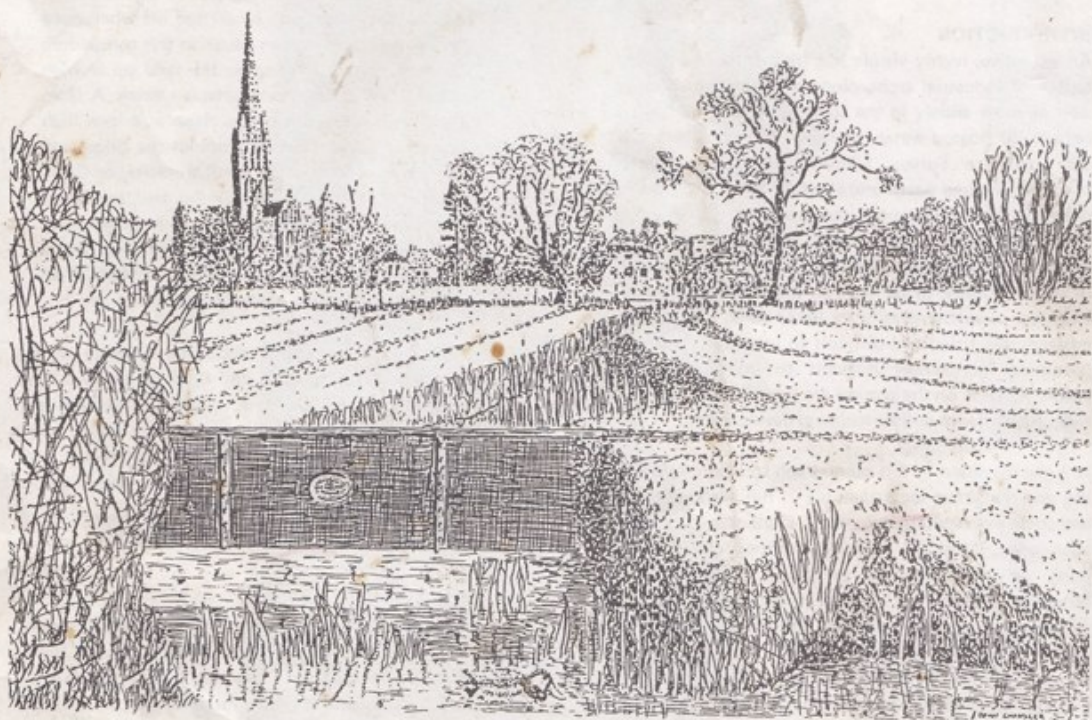
Cast iron sectional aqueduct, part of the West Harnham system.

This Tail Drain continues to Point 3 where it is again crossed by an 'aqueduct' before joining the spillways from Points 4 and 5, turning north-east, passing under the Town Path and rejoining the river. This second aqueduct is unusual and is illustrated on the cover. It consists of a square section (side 32 inch) iron trough fourteen feet in length bridging the Drain between stone piers. On the west side it has an oval plate inscribed 'J Armitage - Maker - Fisherton Iron Works - Salisbury'.

The water course crossing the aqueduct is a Carriage in that it is carrying water for area C but it also acted as a Carrier and spilled water along its own length. It was controlled at Point 6 either by a wooden Hatch that has disappeared or by a turf stop. Point 6 is on a narrow Main Carriage (now only a shallow depression) running close beside the wider Main Carriage which is still used as a river overflow. Both were controlled by adjacent Hatches on the river at Point 7 but the brick and stone lined channel of the former has been filled in. The ruins of the wider three-paddle Hatch are best seen from the other side of the river (from Middle Street playing field).

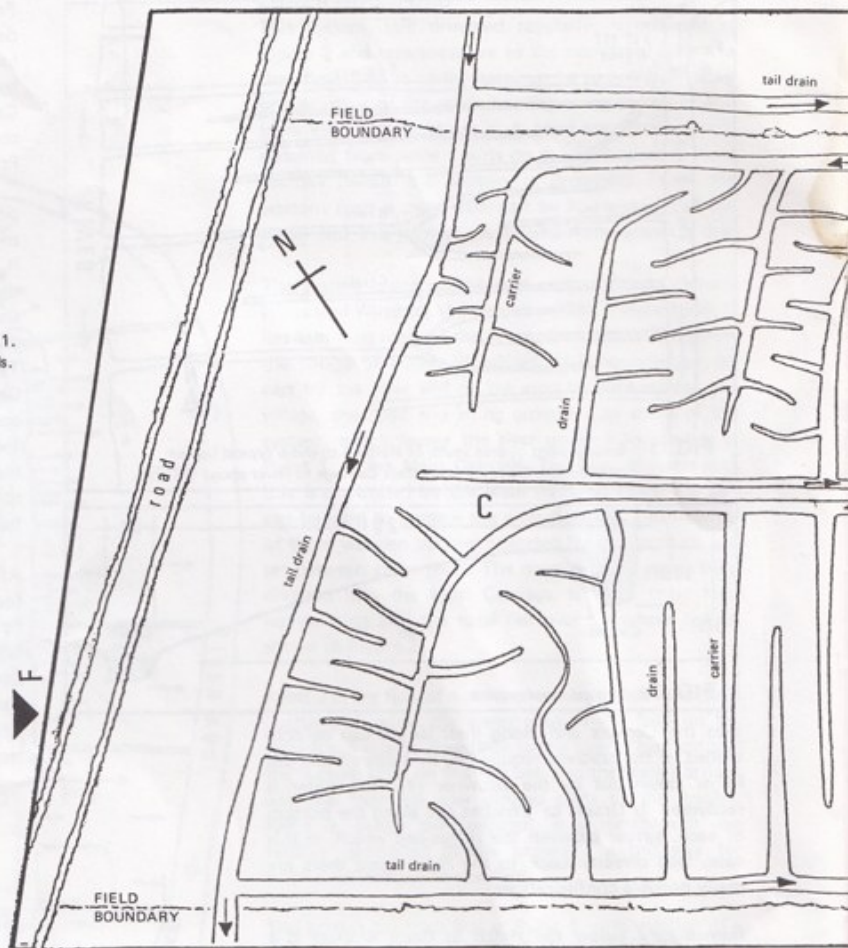
FIG. 4

Enlargement of area between points 10 and 11.
Distance from road to river is about 300 yards.

The area between Points 10 and 11 enlarged in Figure 4 shows more clearly the hierarchy of water courses — Main Carriage, Carriage, Carrier, Drain and Tail Drain. However the definition of each has to be qualified. While Carriages do not usually spill direct onto pans they do here — for example at Point A from the Main Carriage and at Point B from a Carriage; and at Point C a Carriage spills directly into an adjacent Tail Drain without any intervening drain.

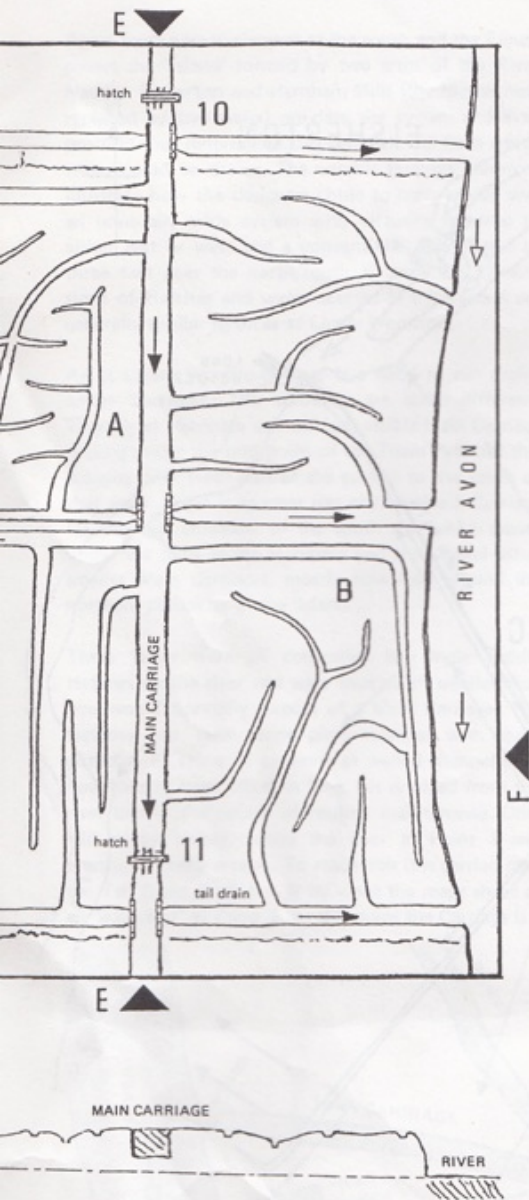
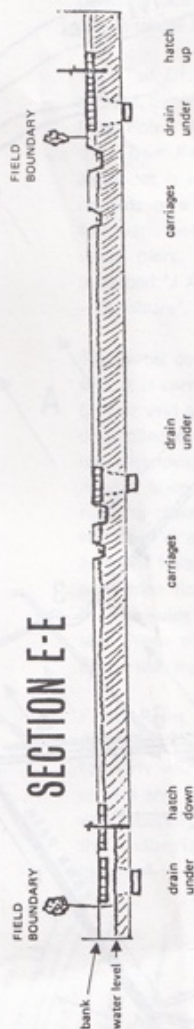
The sections through this area shown in Figures 4a and 4b indicate the very slight gradient from the North to South but the greater drop from West to East to enable the Tail Drains to pass under the Main Carriage.

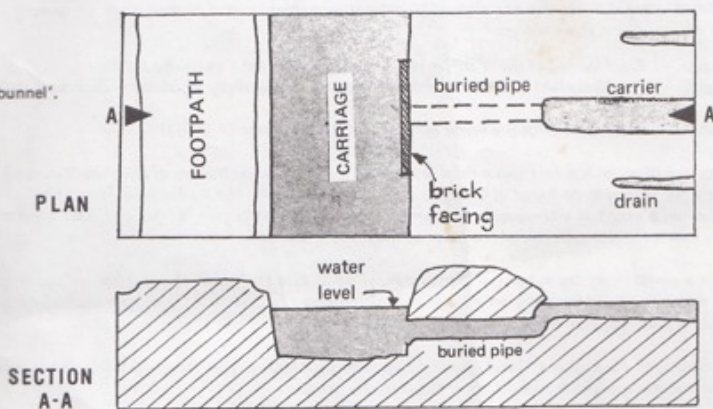
FIG. 7a Detail of 'bunnel'.

Below the dam each individual Carrier is filled directly through a culvert, known locally as a bunnel. To the unaccustomed eye it looks from the dry system as if water runs from the Carrier on top of the ridge, westwards, through the culvert into the Carriage rather than the reverse. The section drawing in Figure 7a indicates how the water level has to be visualised. The culvert itself is a pipe of some twelve inch diameter set, at the Carriage end, in a brick facing. It is not clear why the simpler system north of the dam could not have been used. The maps show the system in fair detail to the west of the path but not at all to the east.
